30 August 2022

**9 Henry Street, Erf. 4838, Port Alfred
ASSESSMENT AND STRUCTURAL REPORT**

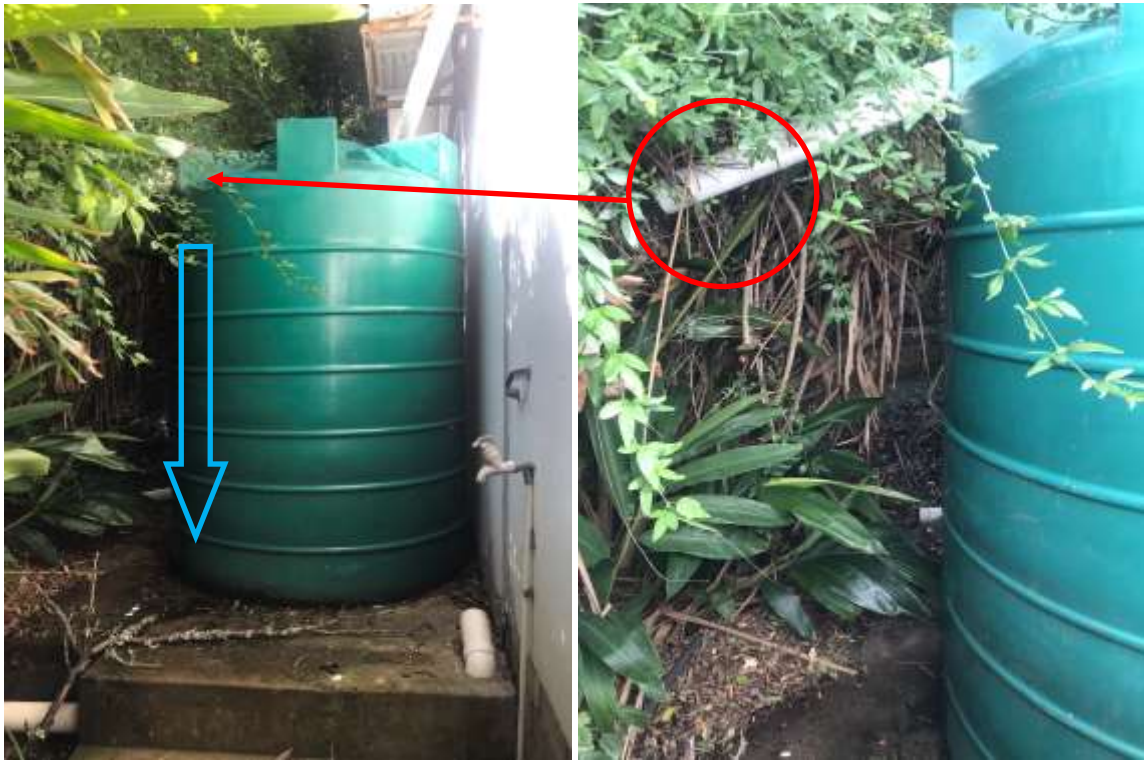
1. Cracks in the bedroom walls indicate subsidence of this area. The cracks are typical of those caused by subsidence of the founding material, being straight vertical cracks that widen to the top of the crack.
2. Cracks in the tiled floors correspond to the vertical cracks in the walls, also indicating subsidence of the founding material.
3. Horizontal cracks were visible along the DPC level of the exterior walls.
4. Although there are no indications of foundation failure, differential subsidence has occurred in the strip foundations in the northern corner of the structure.
5. Upon exposure of the foundations, foundations appear to be intact.
6. Founding material was saturated, clayey soil.
7. The overflow to the water tank discharges down the side of the dwelling.

Tank discharge saturating soil

3. All downpipes to be checked to ensure that they are not leaking and discharge water away from the dwelling.
4. All tank overflows to be directed away from the dwelling into the storm water channel.

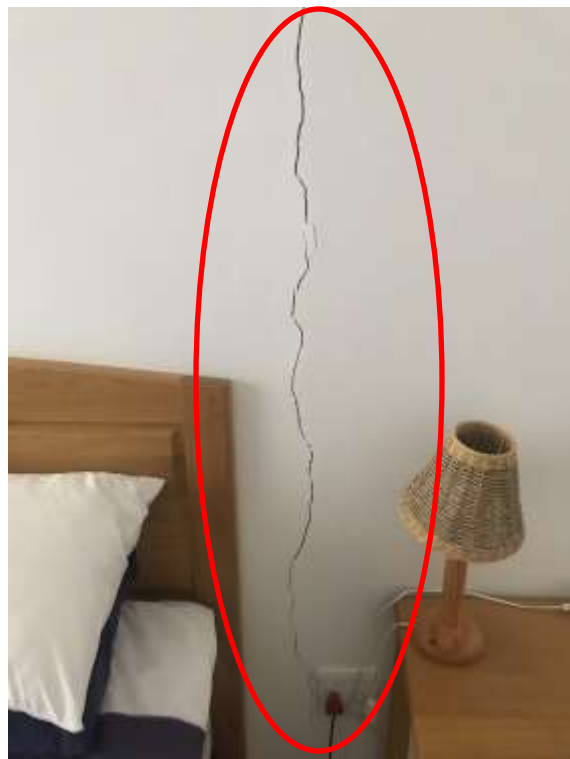
Crack in second bedroom corresponding to crack in next picture (corner bedroom)

1. Foundations are to be underpinned using the following method:
2. Excavate 1m wide x 1m deep x width of the foundation in alternating blocks under the existing foundation.
3. Cast mass concrete, Class 20/19, into blocks under the foundations.
4. Allow to cure for at least 5 days.
5. Excavate remaining alternating soil blocks and repeat the above.
6. Excavation to be for 3m along the side exterior wall and for the extent of the two front bedrooms along the street facing exterior wall.
7. Once underpinned, cracks are to be repaired using the crack repair method specified.

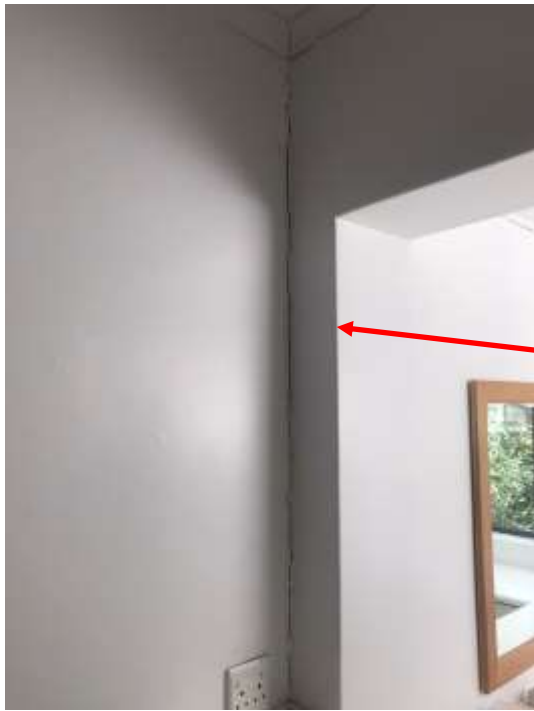
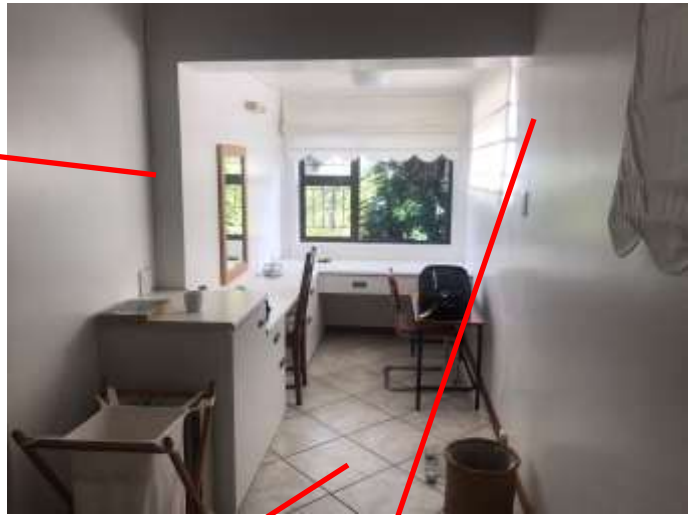
Crack corresponding to crack in second bedroom; View of corner bedroom indicating cracks

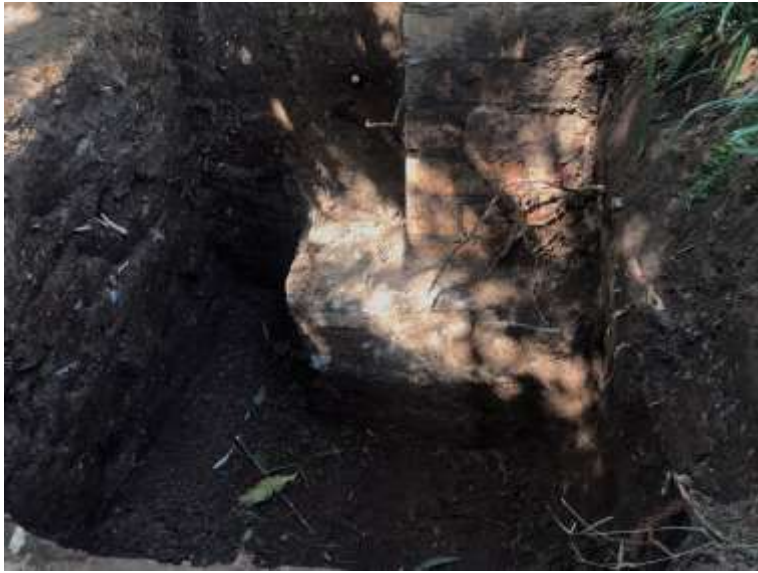
Excavated corner where underpinning is to occur

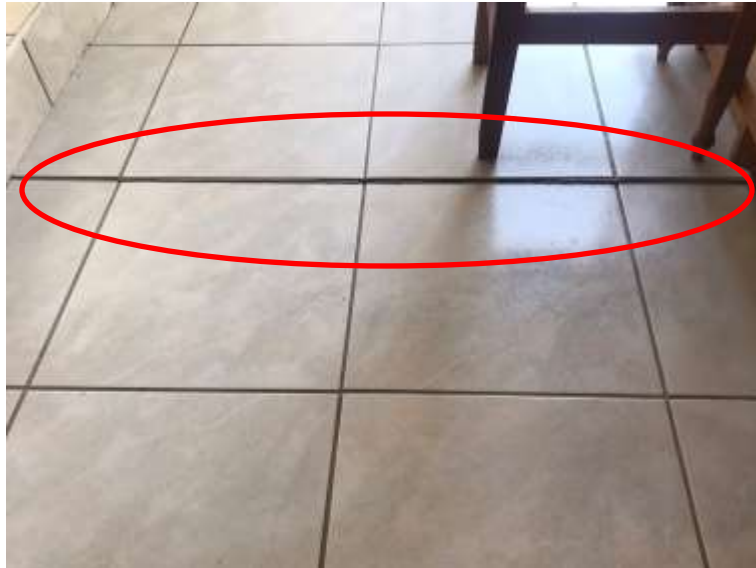
1. The tiled floor in the bar area shows a straight, distinct crack and subsidence of the surface beds slab behind the built water tank. The difference in floor level is roughly up to 10mm in places.
2. The exterior wall behind the water tank shows horizontal cracking typical of subsidence of the foundations.
3. Horizontal cracks were visible along the DPC level of the exterior walls behind the water tank.
4. Although there are no indications of foundation failure, possible differential subsidence has occurred in the strip foundations behind the built water tank. It was not possible to expose the foundations due to the existing built entrance stairs.
5. The water tank appears to have no visual signs of subsidence.

Level difference in bar floor, behind tank

1. The surface bed slab behind the built tank is to be demolished and fill under it to be removed.
2. Fill is to be re-compacted in layers not exceeding 150mm thick.
Cast a new 100 thick surface bed, reinforced using ref 193 mesh. Engineer to approve compaction prior to casting a new surface bed.
3. Form a soft-board joint between the existing tank slab and the new surface bed slab. Seal using a flexible sealant.
4. Make good floor finishes and paintwork.

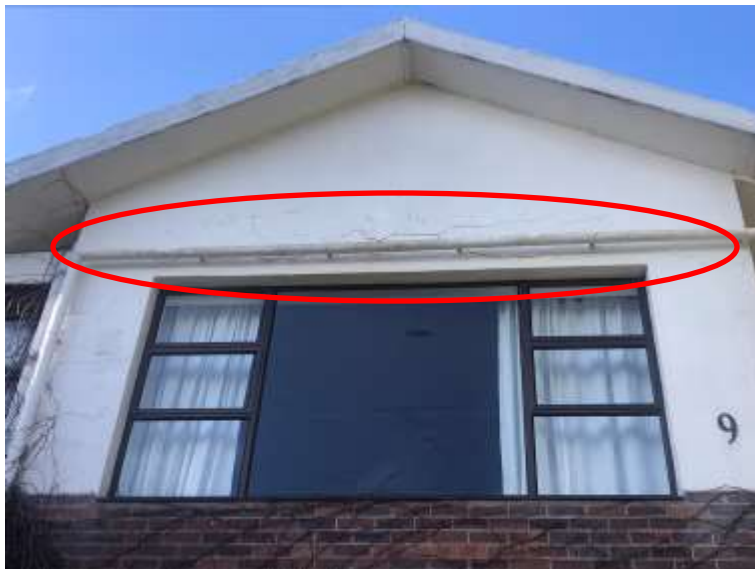
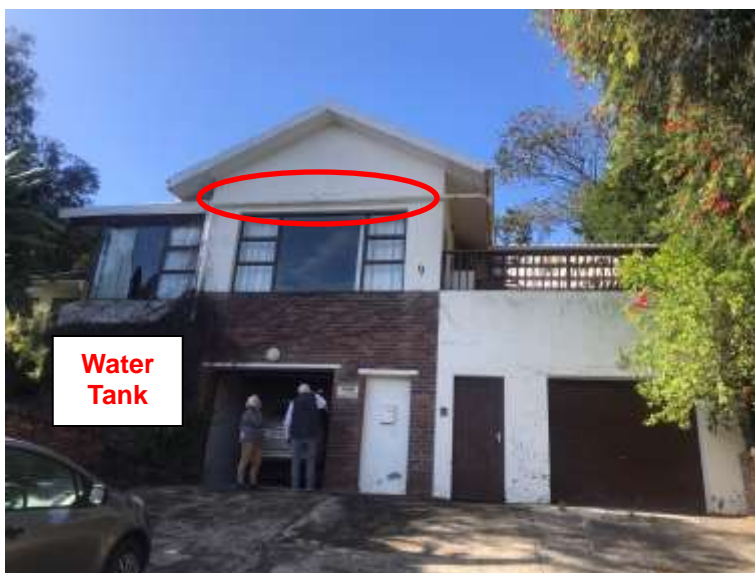
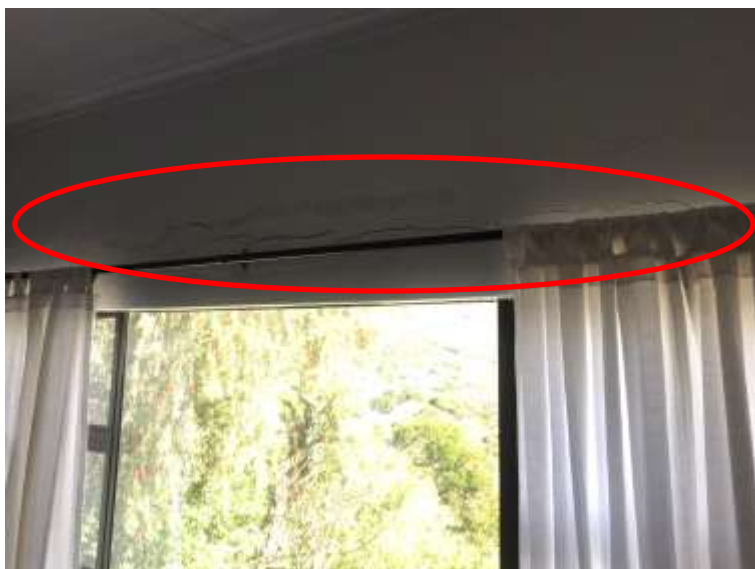
Area 3

1. A horizontal crack is present above the lintol of the street facing window. The window is in excess of 4m wide; a vertical crack is present at mid-span, indicating failure of the lintol.
2. A brick gable wall is constructed above the lintol over the window.

1. Repair the cracking above the existing lintol using the crack repair method specified.

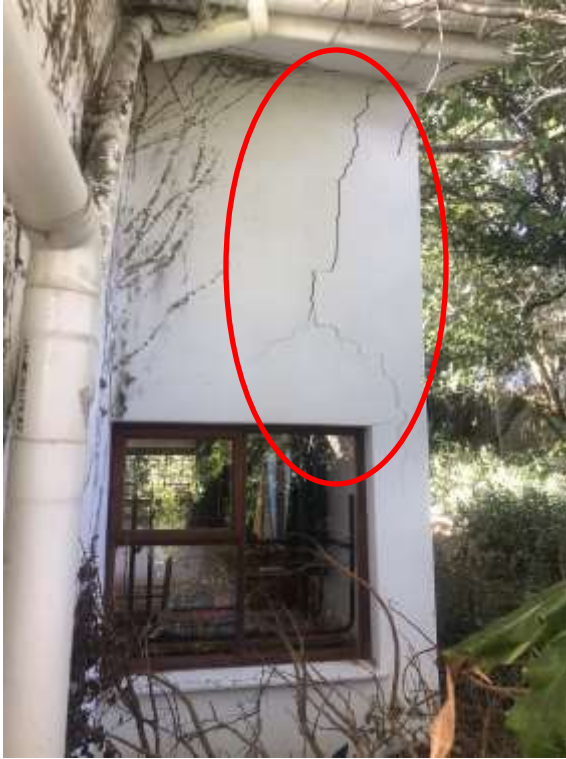
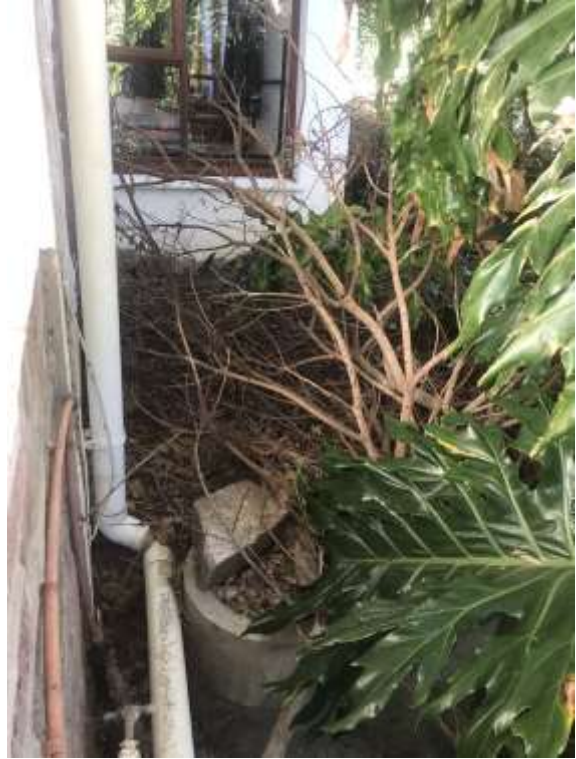
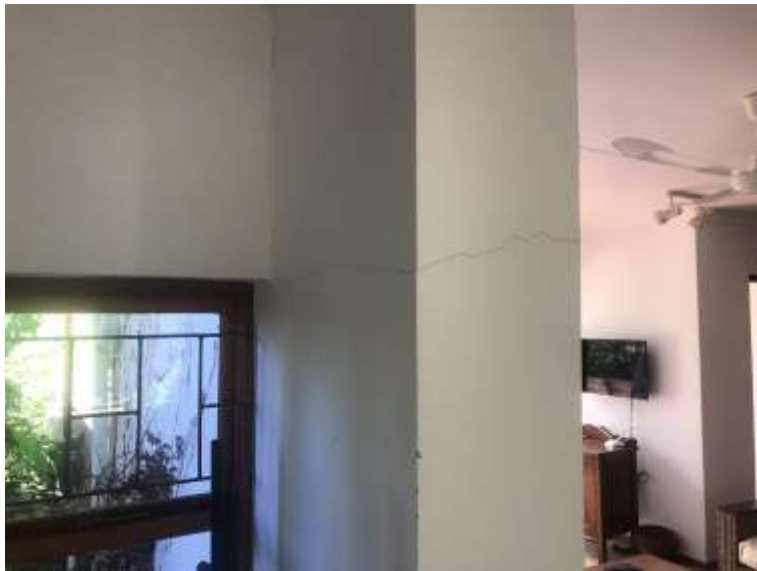
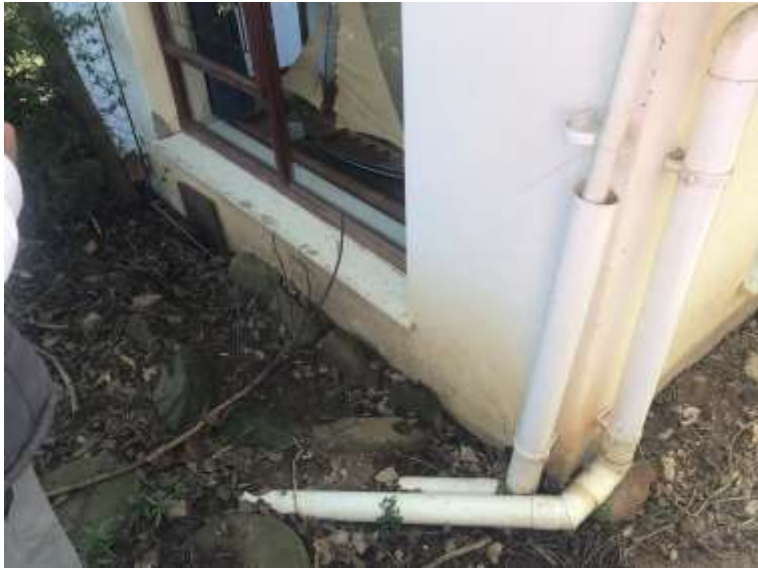
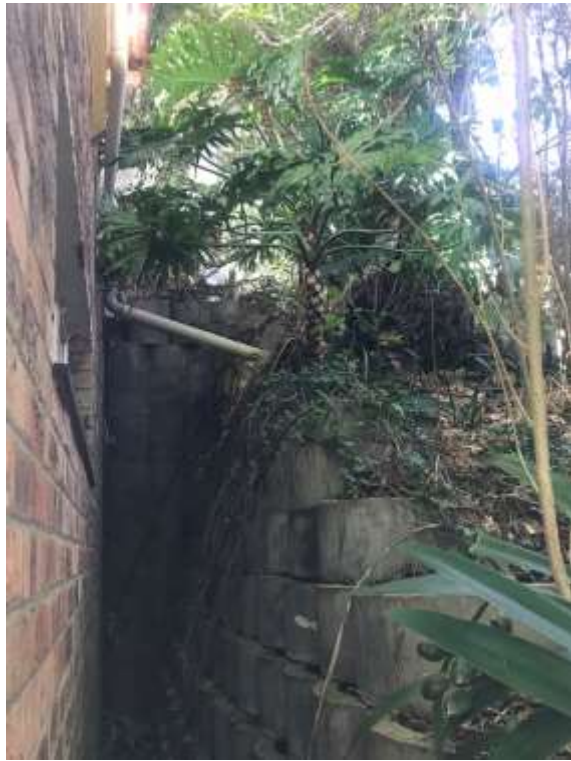
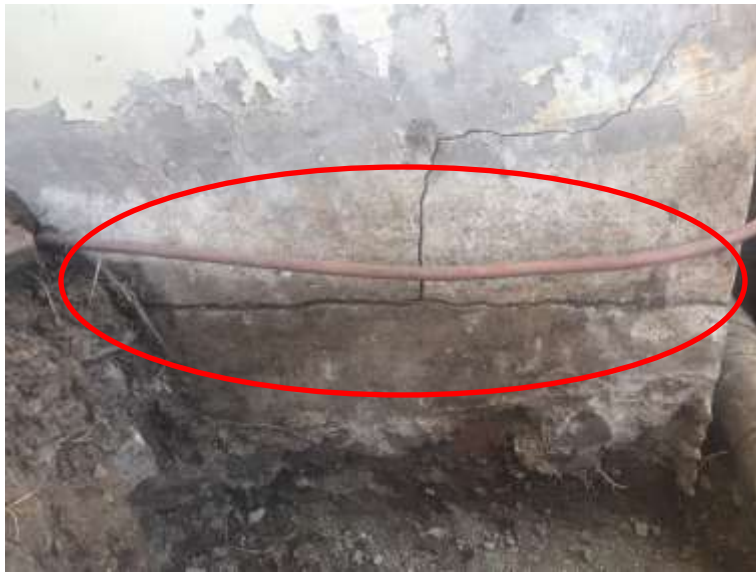
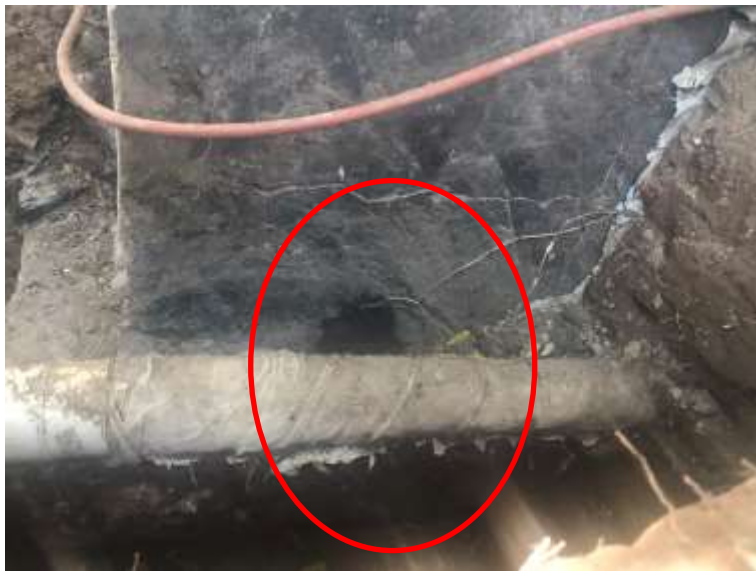
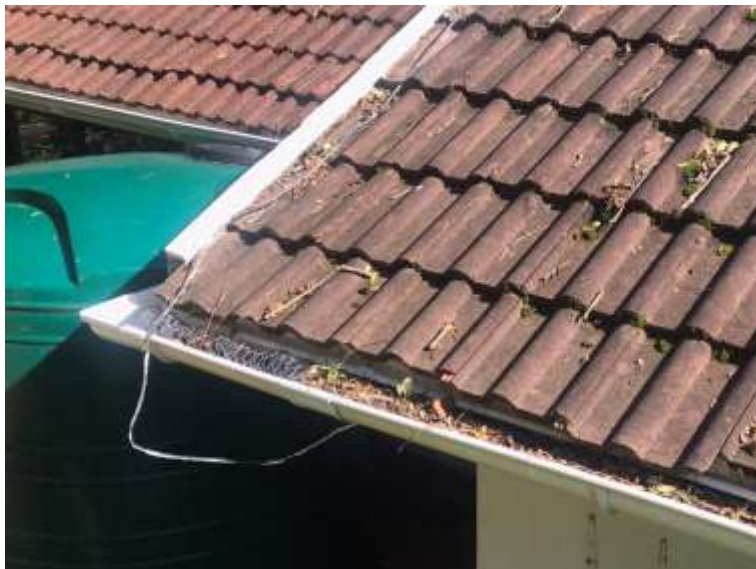
Area 4

1. Staggered cracking is present in the exterior skin only of the dwelling.
2. No significant cracks are present in the internal skin.
3. No cracks are visible in the tiled floors.
4. Upon exposure of the foundations, a leaking pipe was discovered.
5. Founding material was saturated, clayey soil.
6. A horizontal crack at surface bed level is visible.

Foundations are to be underpinned using the following method:

1. Excavate 1m wide x 1m deep x width of the foundation in alternating blocks under the existing foundation.
2. Cast mass concrete, Class 20/19, into blocks under the foundations.
3. Allow to cure for at least 5 days.
4. Excavate remaining alternating soil blocks and repeat the above.
5. Excavation to be for the length of side exterior wall and for the extent of the wall along the street facing elevation.
6. Exterior skin to be removed, as per Engineer on site, and rebuilt.
7. Lugs are to be drilled into the existing interior skin and built into the new skin to offer stability to the new skin.
8. Once underpinned, cracks are to be repaired using the crack repair method specified.

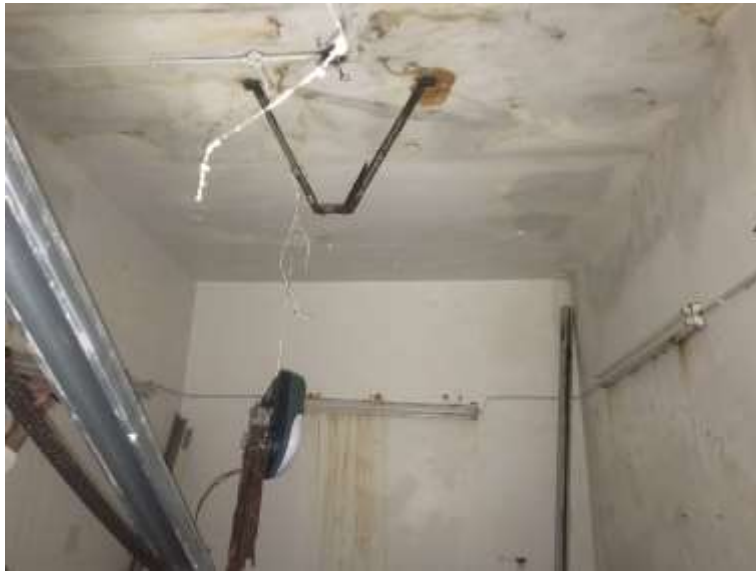
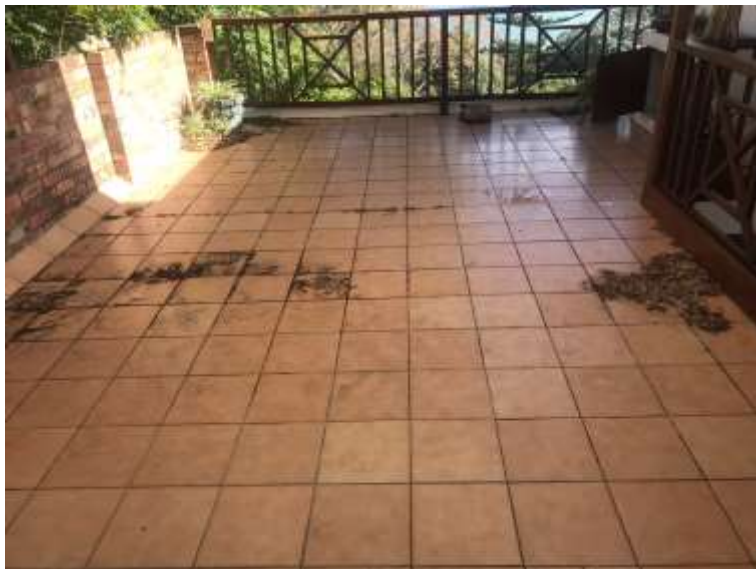
Area 5

1. The basement level garage shows signs of moisture ingress through the hollow core slab above.
2. The tiling on the patio slab above the garage is cracked. Tiles have delaminated in areas.
3. It appears that the waterproofing has been damaged.

1. Remove existing tiles and debris from patio.
2. Cleaning and waterproofing by specialist.
3. Make good tiles and damage caused by moisture in garage.

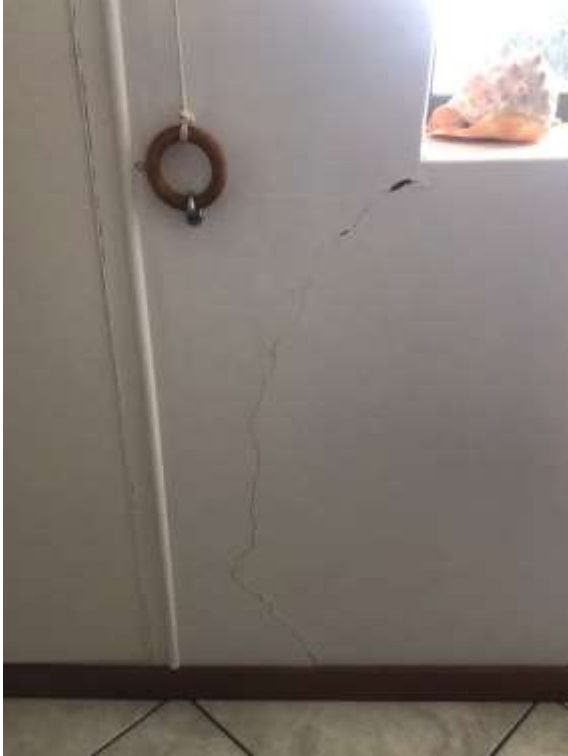
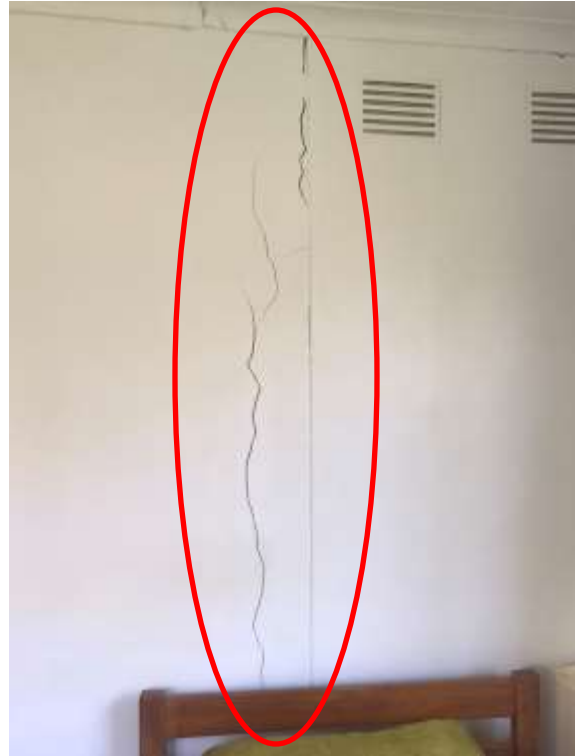
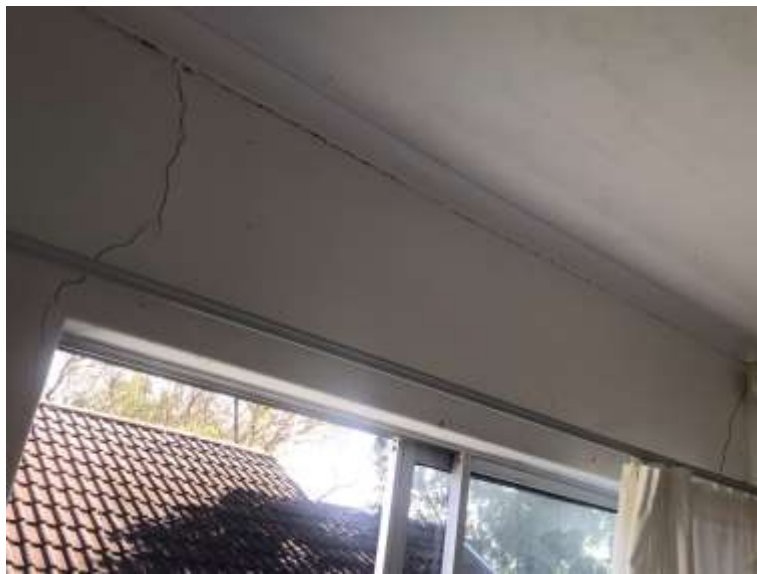
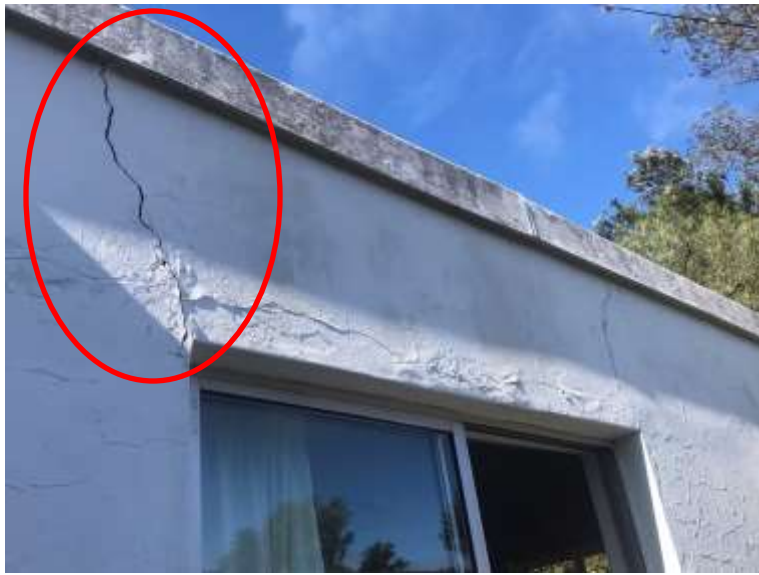
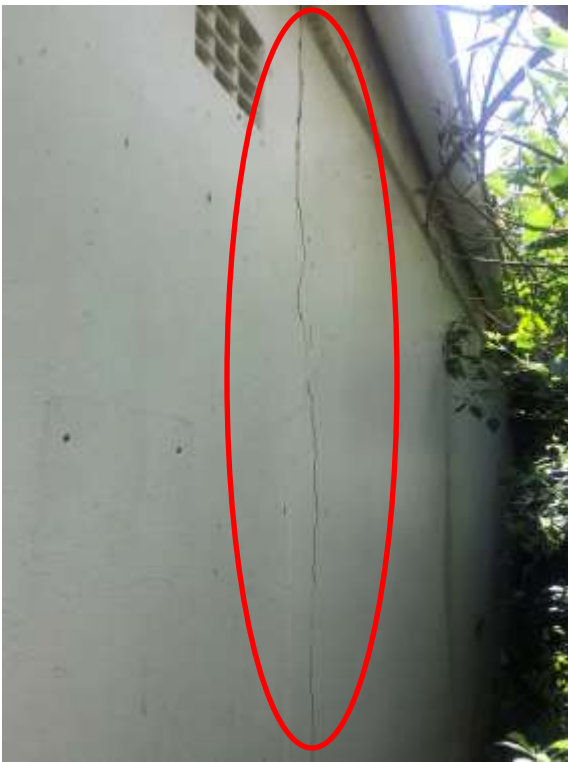
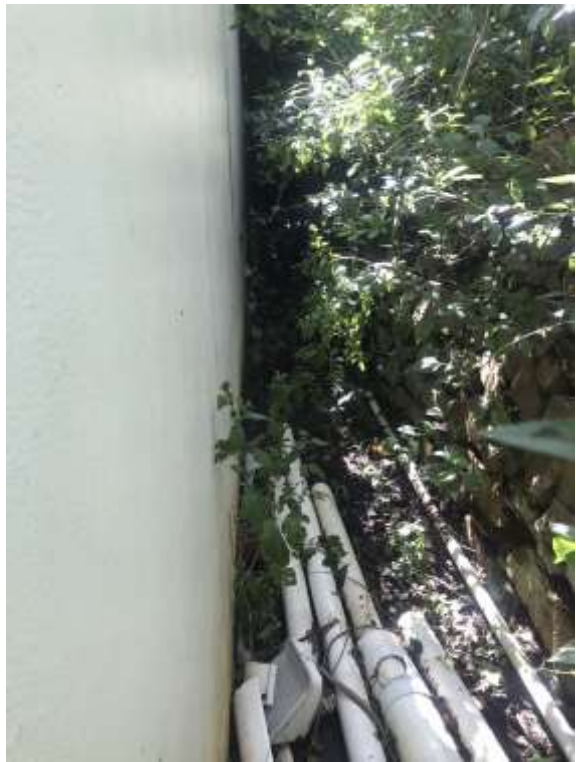
Area 6

1. Cracks in the bedroom walls indicate subsidence of this area. The cracks are typical of those caused by subsidence of the founding materials, being straight vertical cracks that

widen to the top of the crack.

2. Cracks in the tiled floors are in line with the vertical cracks in the walls and also indicate subsidence of the founding material.
3. The interior is damp.
4. There is no downpipe present on the gutter, causing water from the roof to discharge on the ground at the foundations.

1. Repair cracks using method specified.
2. Make good finishes.
3. Install a downpipe to gutter directed away from structures to stormwater channel.
